Auckland Art Gallery Toi o Tamaki -
integrating the new with existing heritage

Auckland Art Gallery Redevelopment

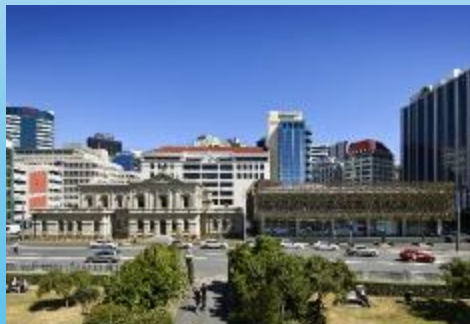
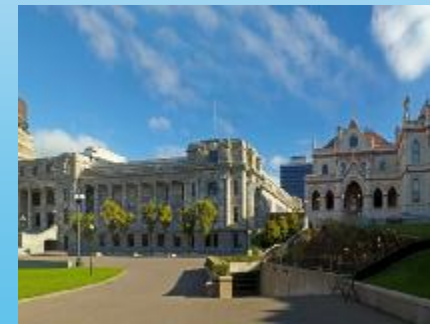
Solutions - Strengthening Options

- establish existing strength accurately, to minimise strengthening
- supplement existing system with new elements
- provide total new system
- base isolate to reduce seismic impacts

These are generally in increasing order of cost of solution, and necessity with higher seismicity

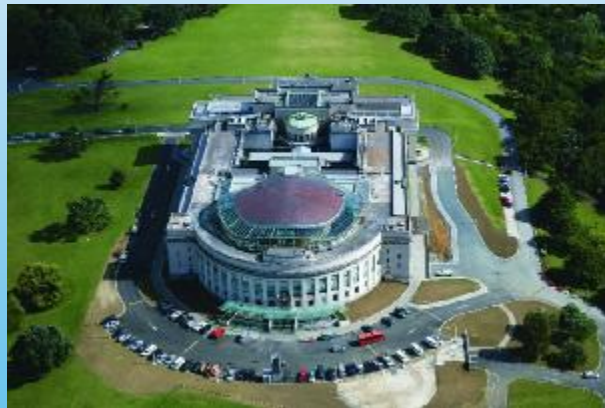
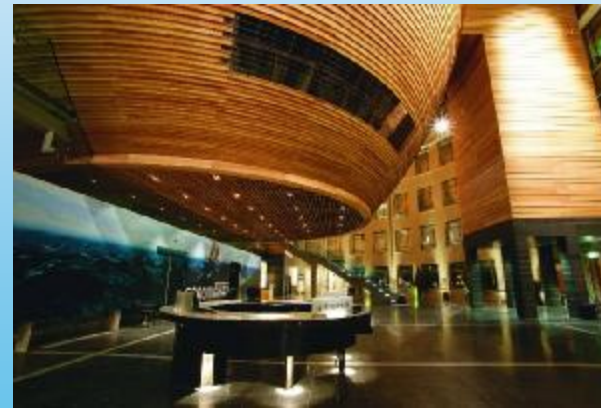
Solutions - Assessments

IEP – very crude
Hand checks
Computer assessments
Earthquake simulation

increasing cost and sophistication
- greater certainty of performance
- identify specific vulnerabilities
- targeted optimal solutions

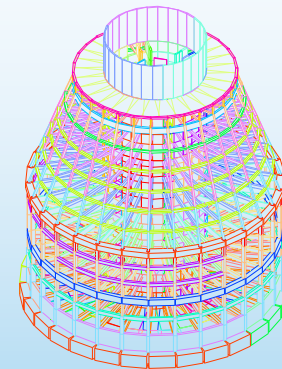
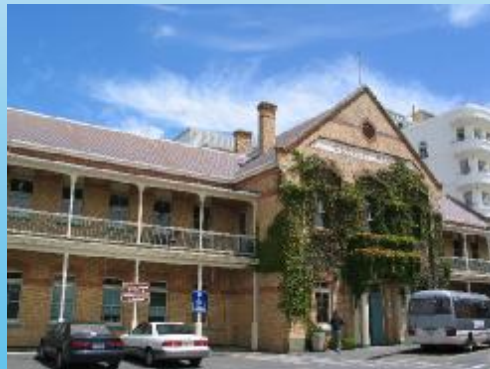
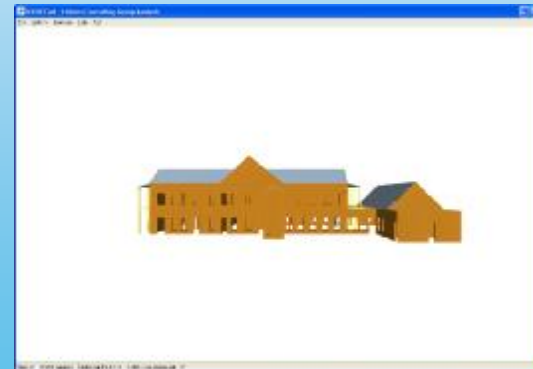
Solutions - Non-Linear Time History Analysis

- takes a detailed computer model of the existing building
- models stiffness and non-linear material properties
- uses real, appropriate, scaled earthquake records
- applied one step at a time
- effects assessed (damage, stiffness changes)
- next step applied
- uses computer power readily available today

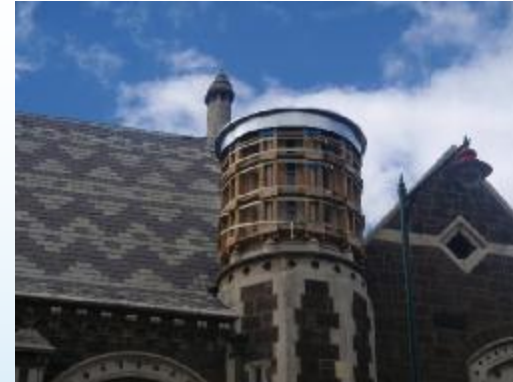
Solutions - Securing

- Parapet braces / ties
- Chimneys
- Wall to floor connections
- Foundation connections
- Floor / Roof diaphragm plywood overlays / steel bracing

Use the strength of existing + hold together + remove / mitigate major hazards eg out of plane wall failures

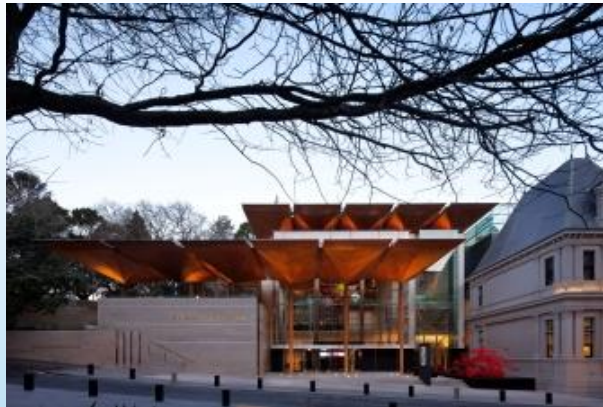
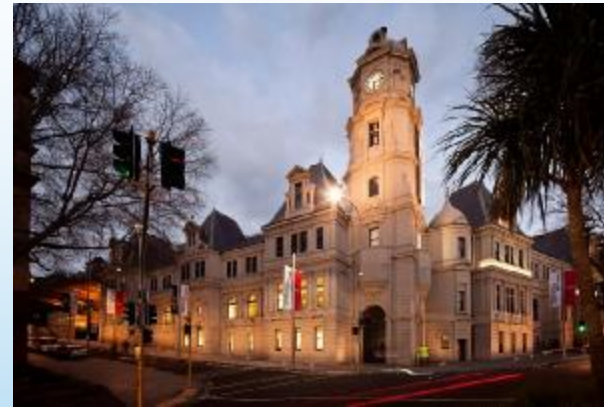
Auckland Art Gallery

- in area of low seismicity
- existing buildings strengthened to >67% of IL3
- sophisticated analysis of existing heritage buildings for optimal solution
- minimal strengthening - new plywood / metal strap diaphragms, parapets
- preservation of existing heritage fabric

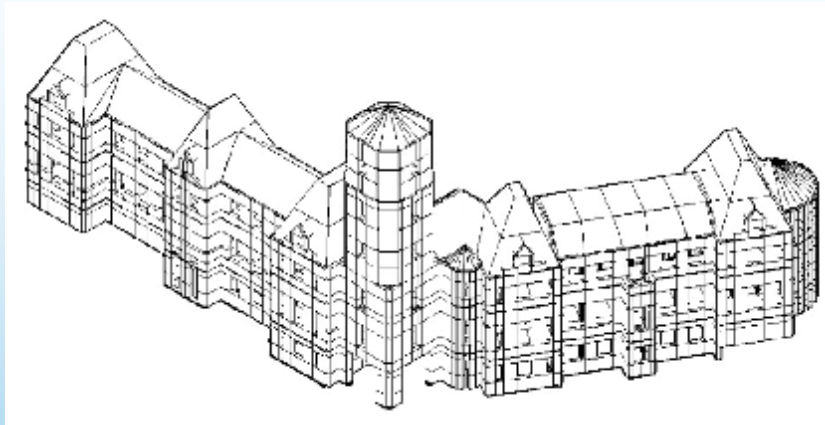
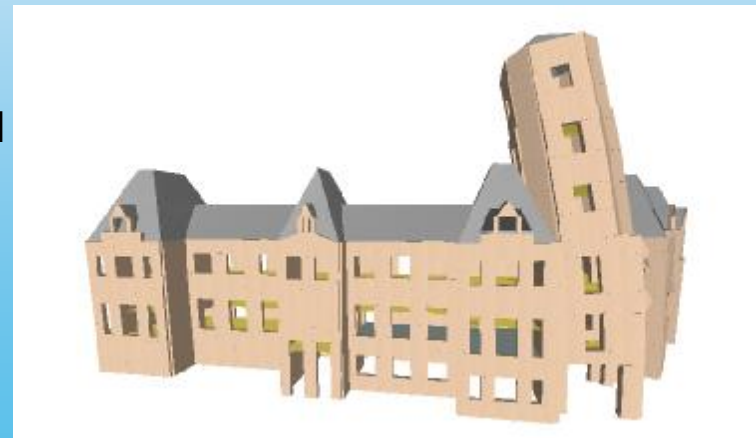
sophisticated analysis of the heritage buildings demonstrated existing walls had >67% of IL3 strength, but parapets and roof and floor diaphragms needed strengthening

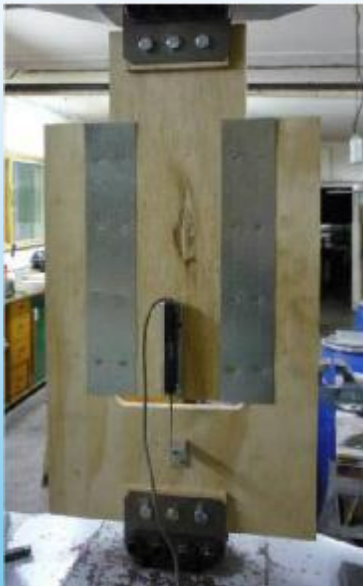
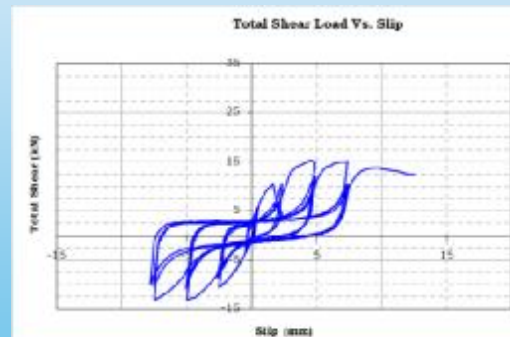
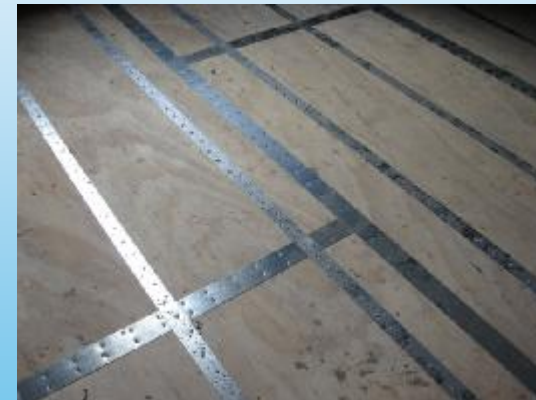
new plywood / stapled sheet metal blocking diaphragms

- common in US, first application in NZ
- testing undertaken to verify cyclic performance
- ductility of 4 achievable

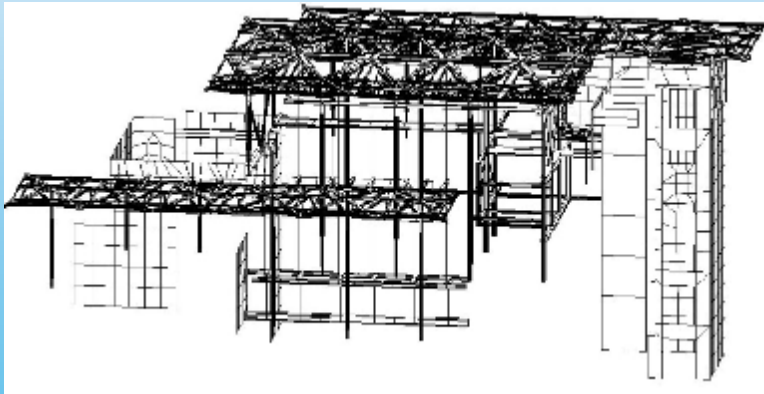
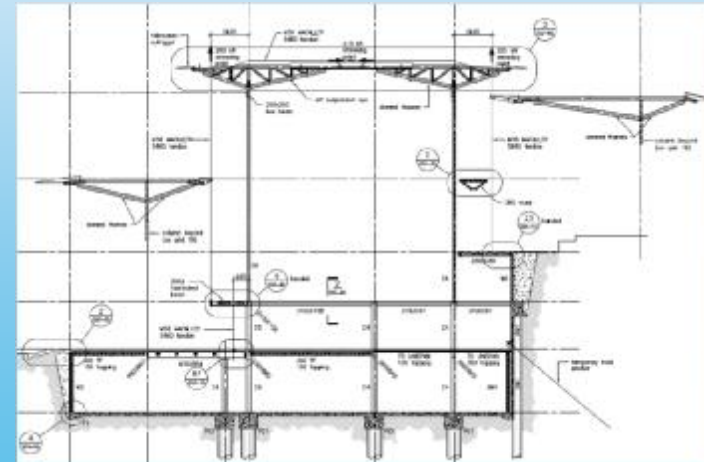
For the new building portions - something equally special required

- separate from Wellesley and Kitchener Wings
- large hung glass facades / canopies
- fine roof structures
- extremely tight tolerances

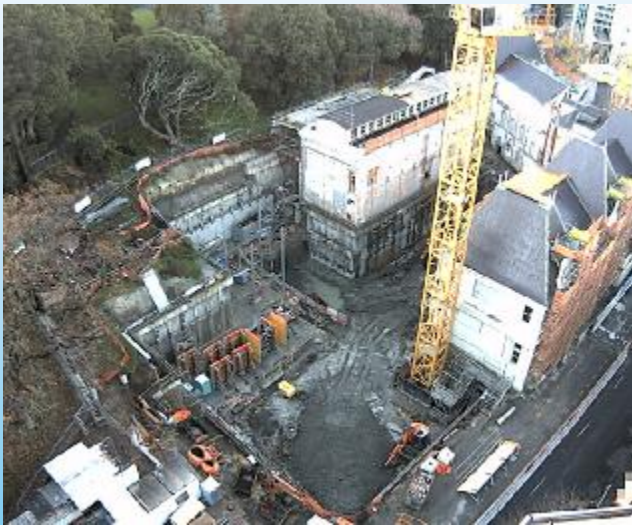
two basement levels excavated
for storage and curatorial space

required careful underpinning of
the existing heritage buildings

East Gallery reinstated to original
form - added floor removed

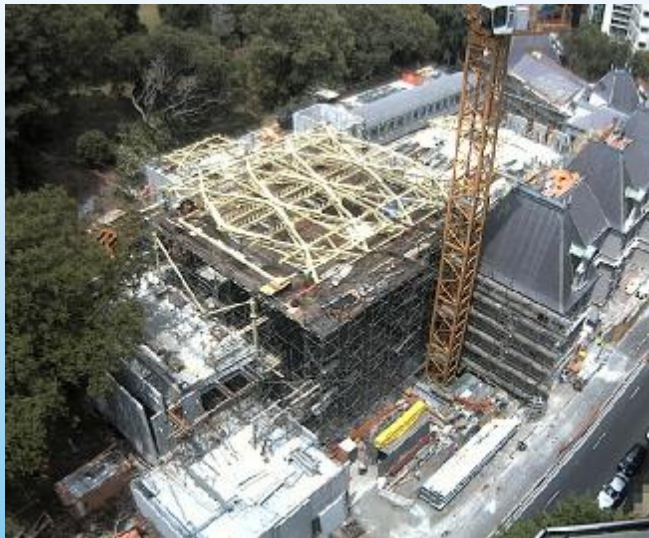
fine floating roof with feature kauri ceilings

tensioned cables support the glass façade

additional mezzanine in Kitchener Wing - challenging to fit it
