Auckland Town Hall Restoration & Strengthening

Mark Hedley
Senior Engineer
Downer NZ Ltd

Mike Farrelly
Construction Superintendent
Hawkins Construction
(On behalf of Downer NZ Ltd)

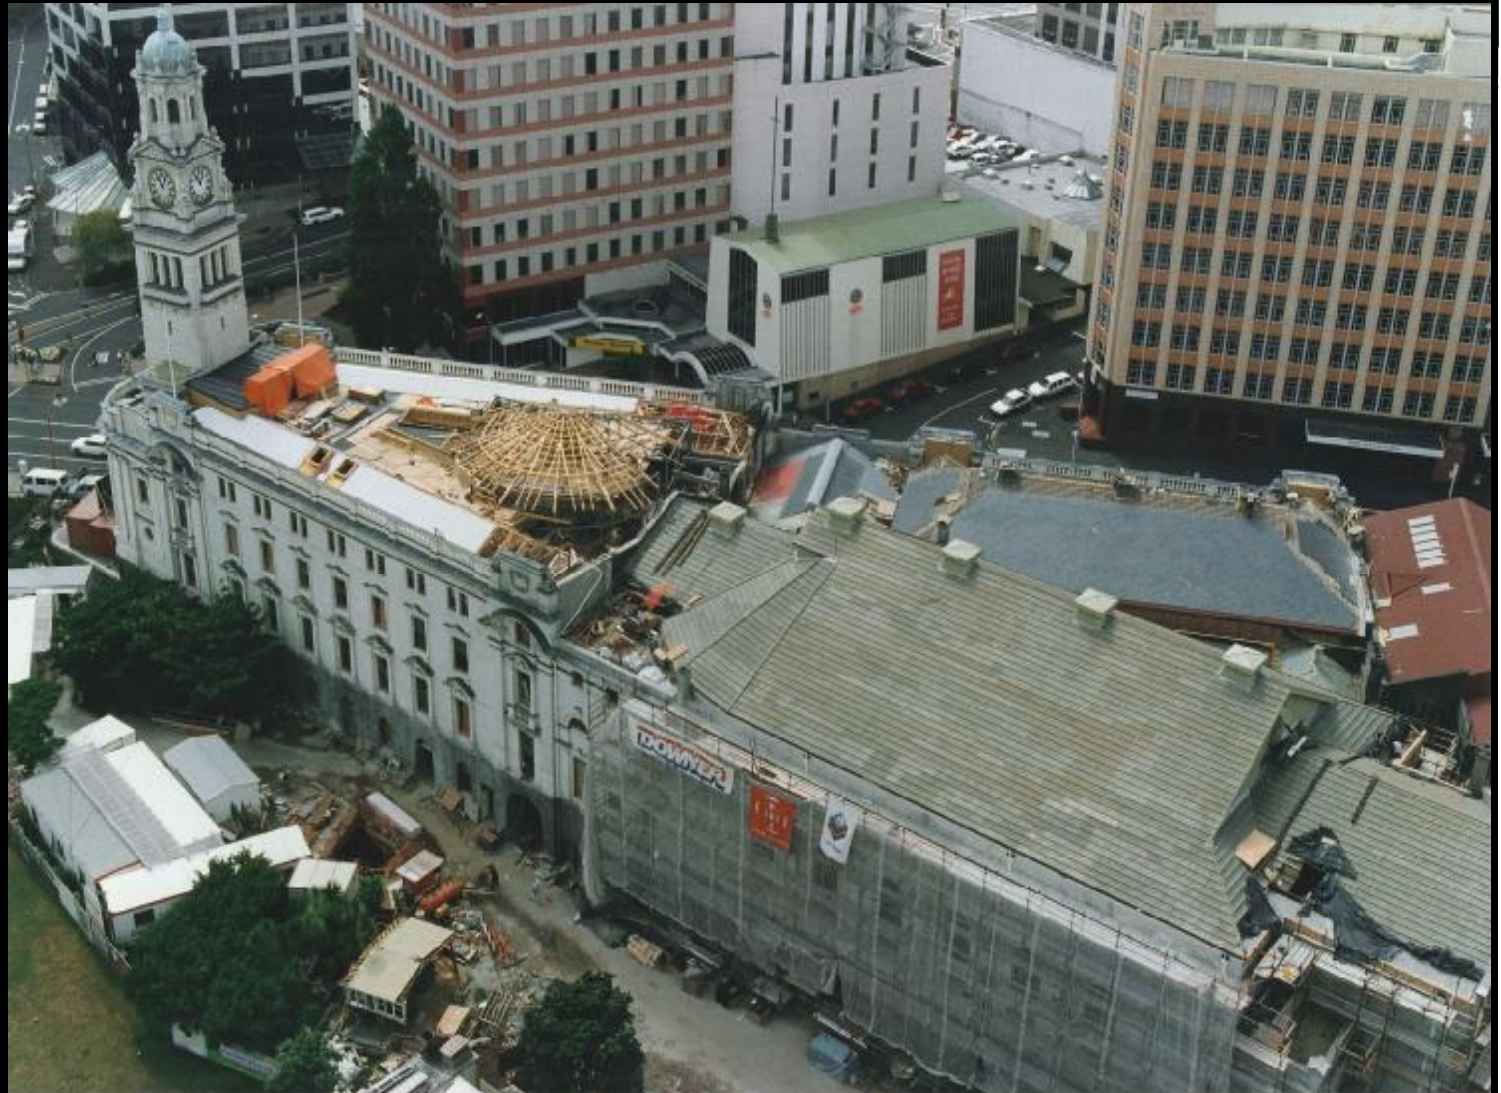
RESTORATION IN PROGRESS 1996

*86 Years later
- 1996*

*Note the
building shape
– acute angles
– lack of
symmetry*

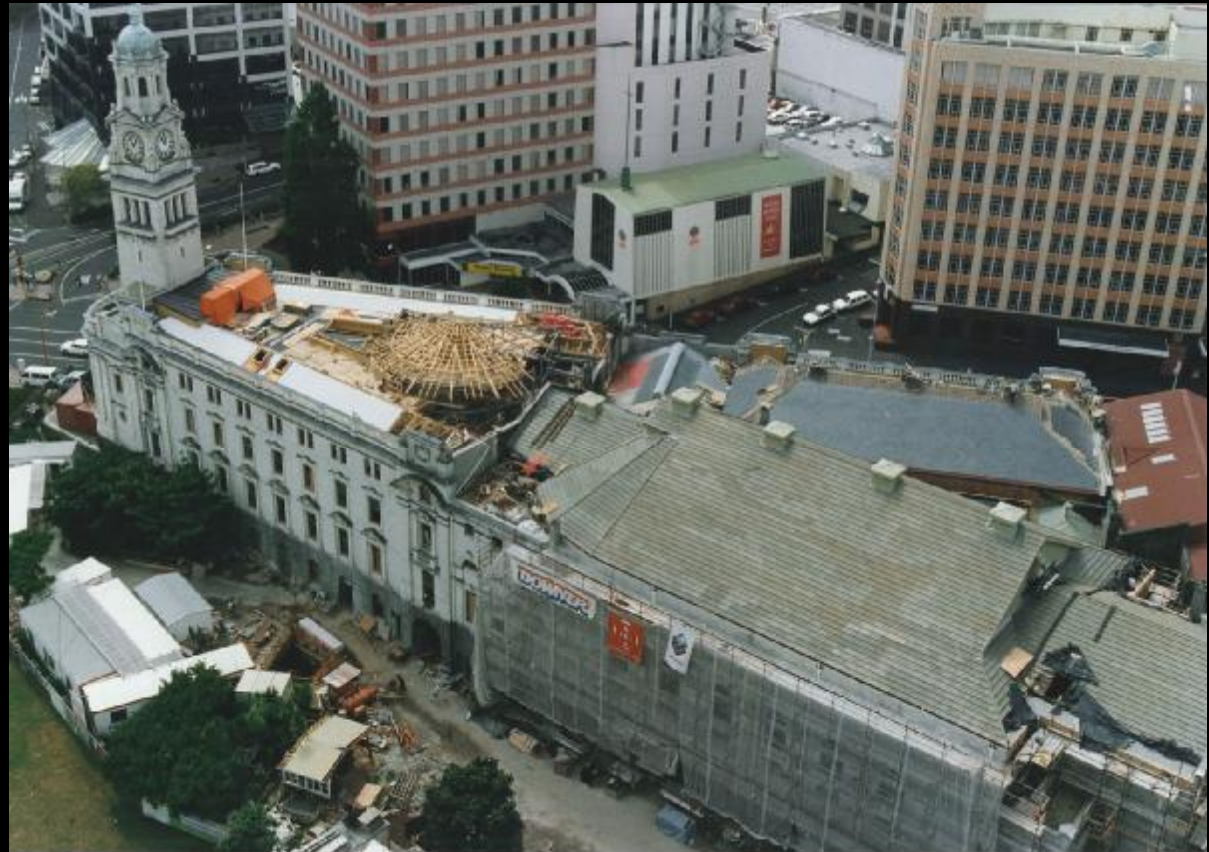
RESTORATION IN PROGRESS 1996

*No room for Piling Rig
- Piles were hand dug!*

*Fibreglass mesh
to strengthen brick walls*

Columns cut into sandstone

*Temporary support
to two levels of brick
whilst tie wall was removed
& replaced*

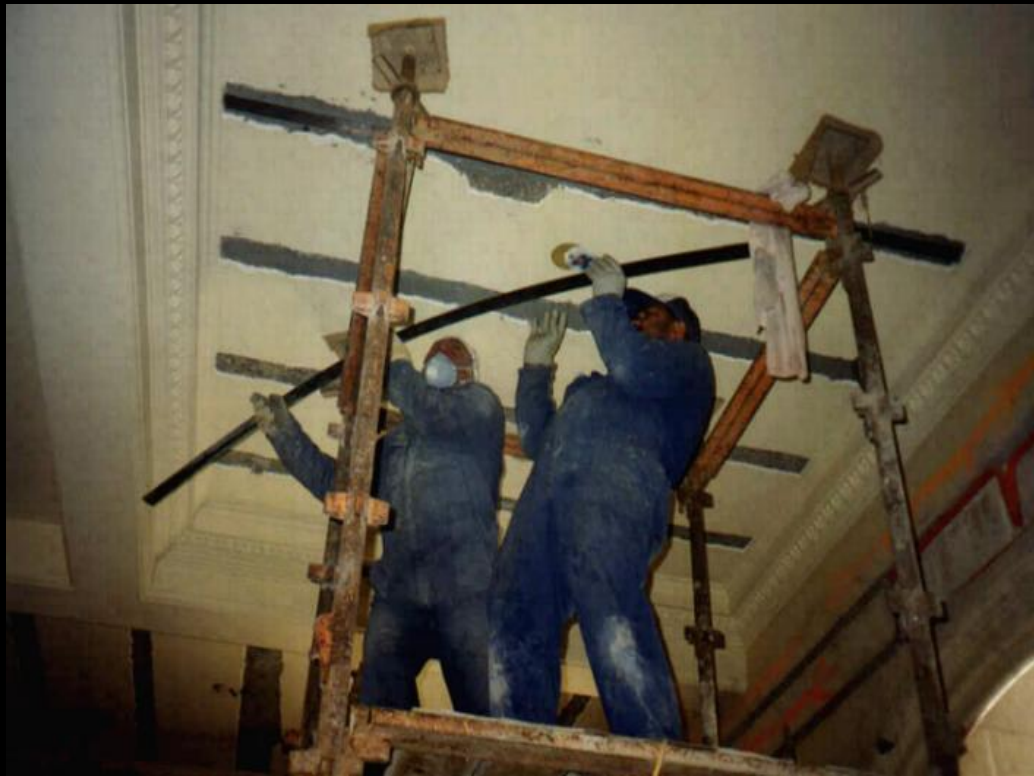
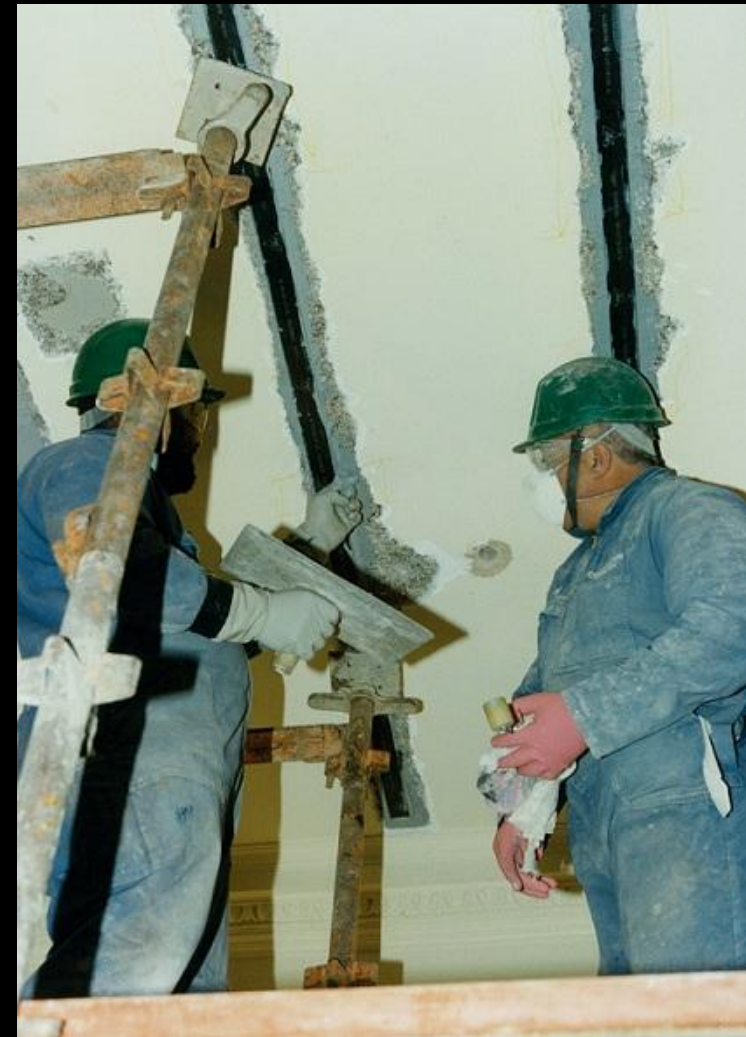
*Innovative
strengthening
methods*

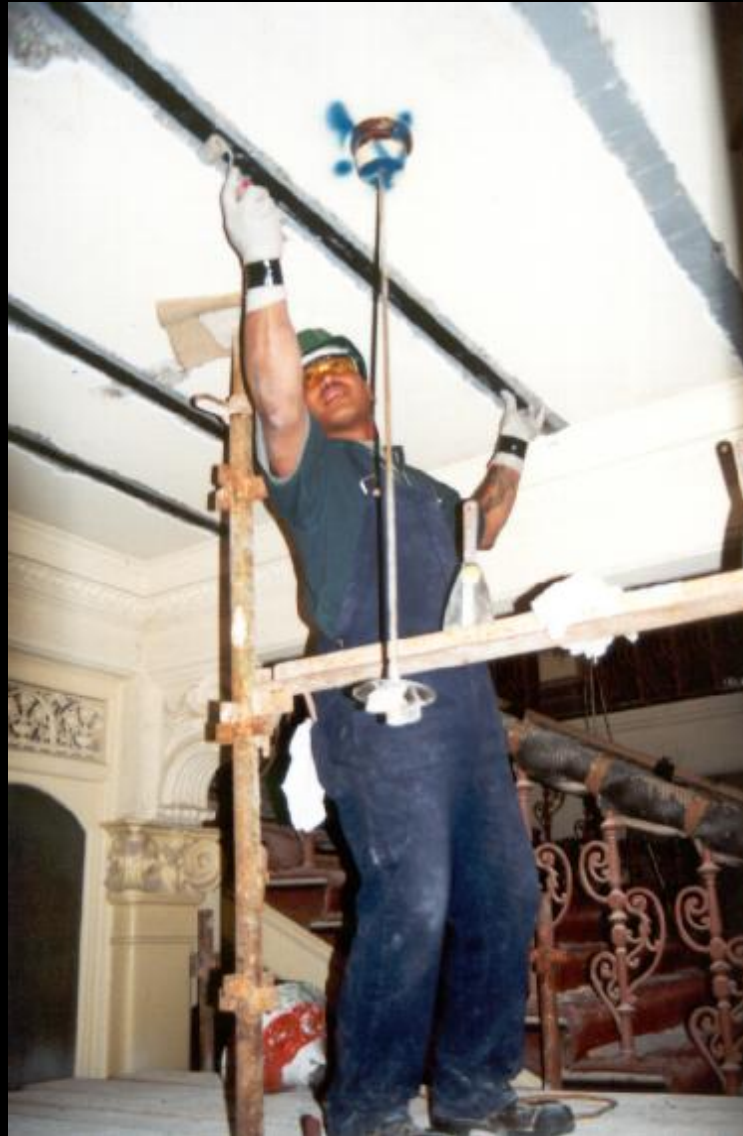
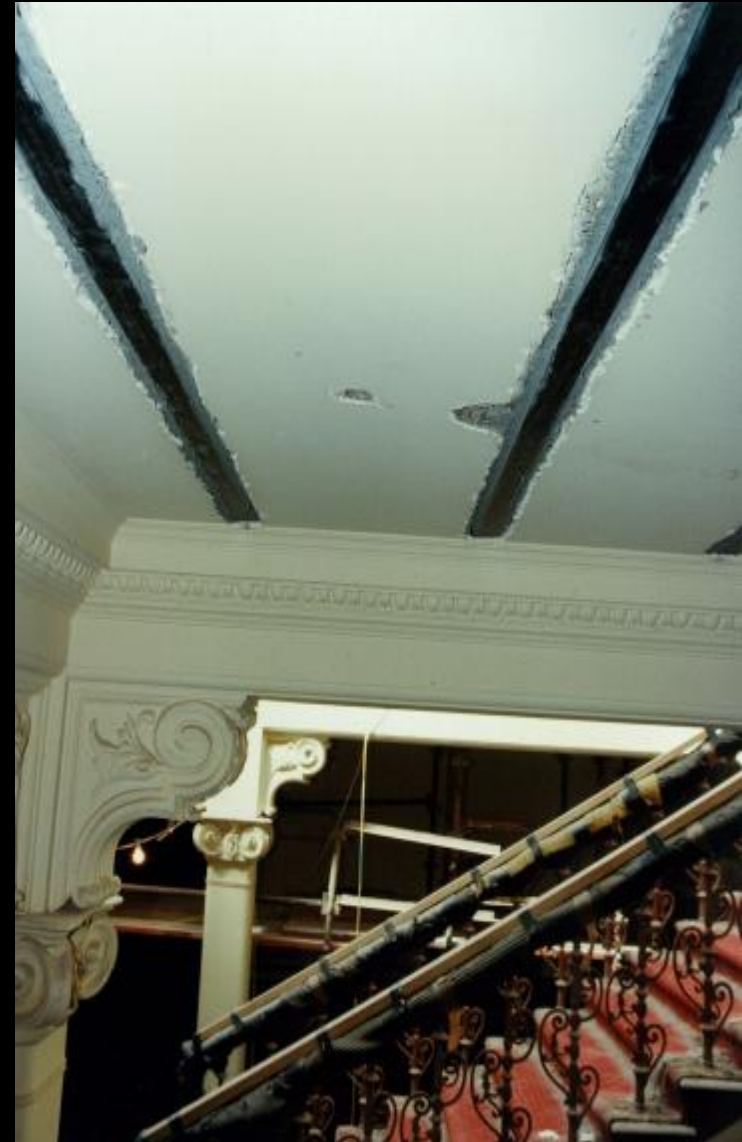
*Innovative
strengthening
methods*

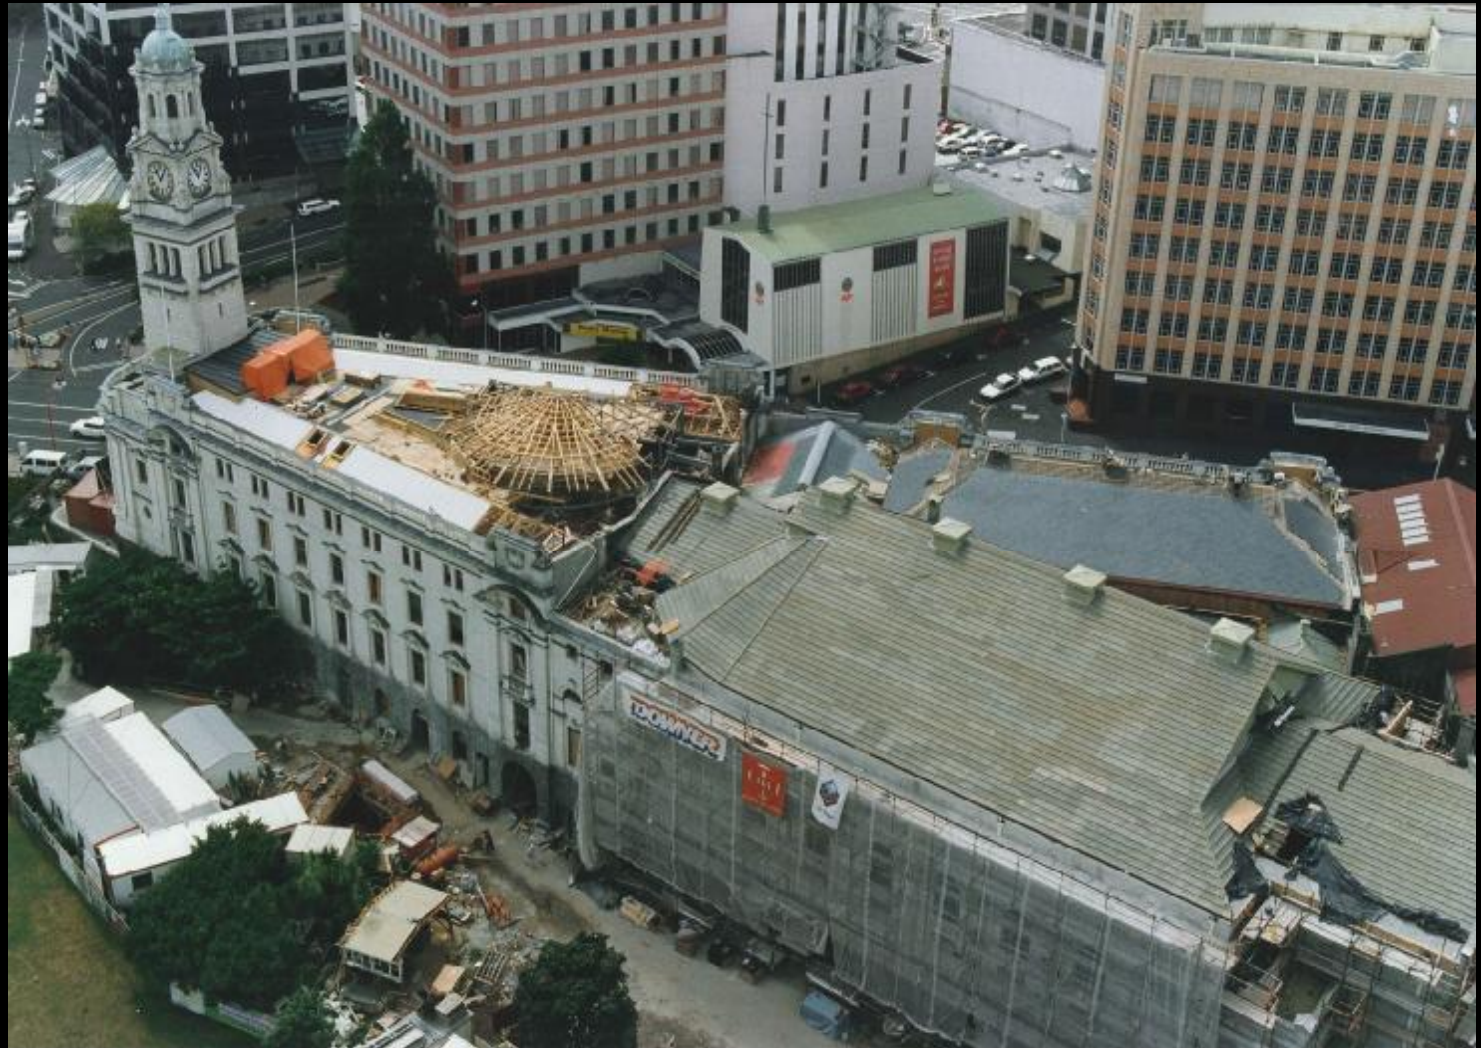
RESTORATION IN PROGRESS 1996

Building new structures on the roof
